REPORT AND VALUATION
UPON
A MASTER PLANNED RESIDENTIAL PROJECT

TITLE NO: KIAMBAA/RUAKA/520, TARAJI HEIGHTS
RUMINYI, ALONG LIMURU ROAD IN RUAKA,
KIAMBU COUNTY

**RE: VALUATION OF TITLE NO. KIAMBAA/RUAKA/520, TARAJI HEIGHTS,
ALONG LIMURU ROAD, KIAMBU COUNTY**

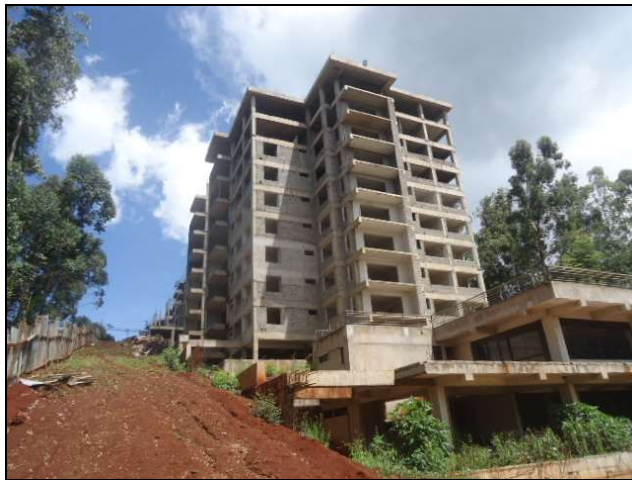
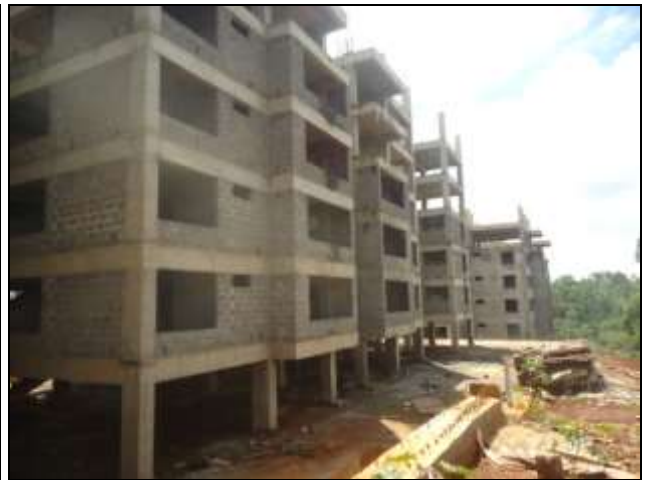
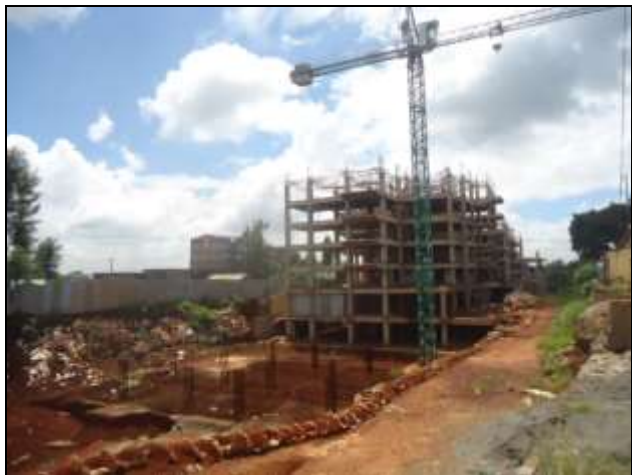
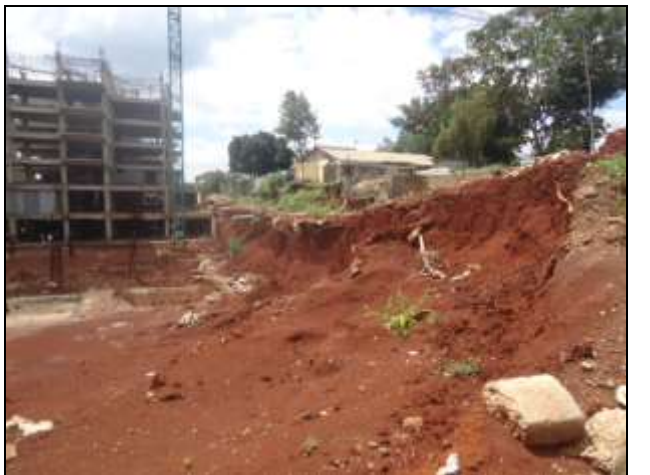
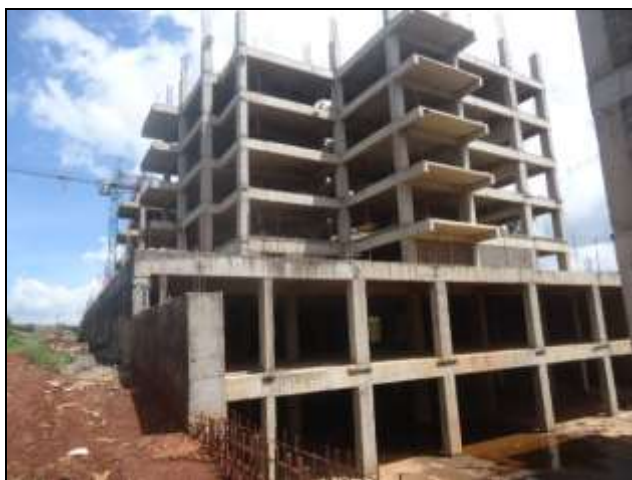
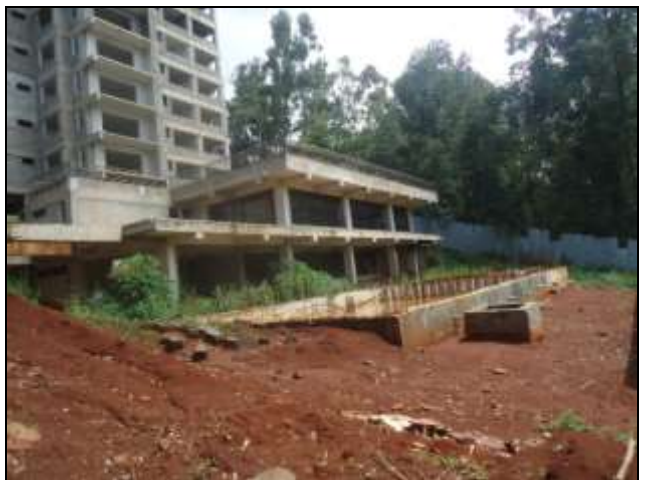
At the time of inspection, the property was vacant with no construction happening.

-Various views of the subject property -

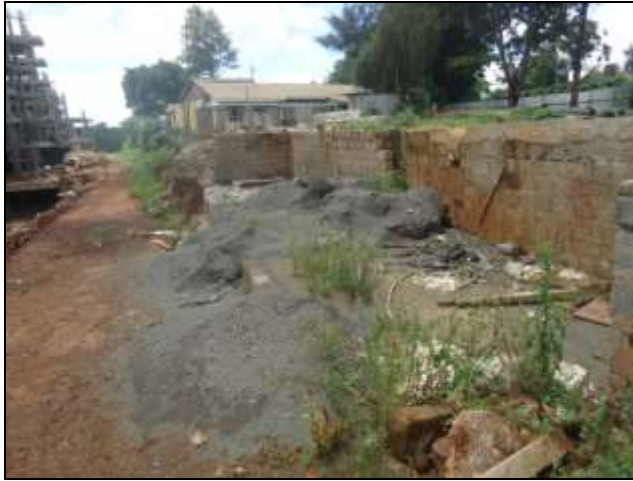
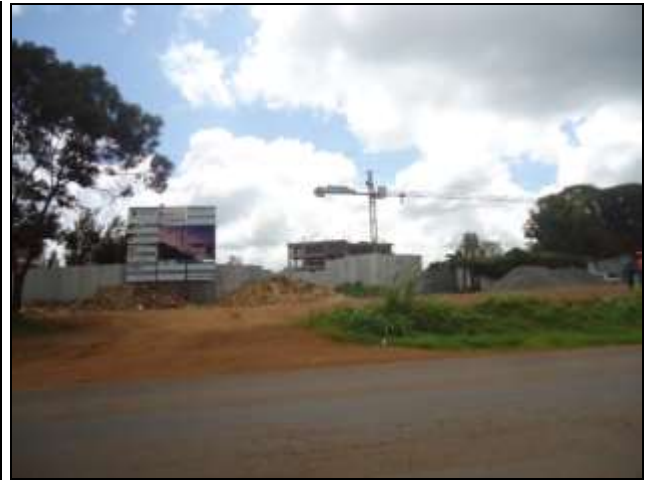
-View of the site entrance & access road-
